# Quality-assured solutions for green roof gardens on concrete deck with zero tolerance for leaks

Y. Edwards<sup>1</sup>, T. Emilsson<sup>2</sup>, J. Malmberg<sup>3</sup> & A. P Skog<sup>4</sup>

<sup>1</sup>*Swedish Cement and Concrete Research Institute, Stockholm, Sweden*

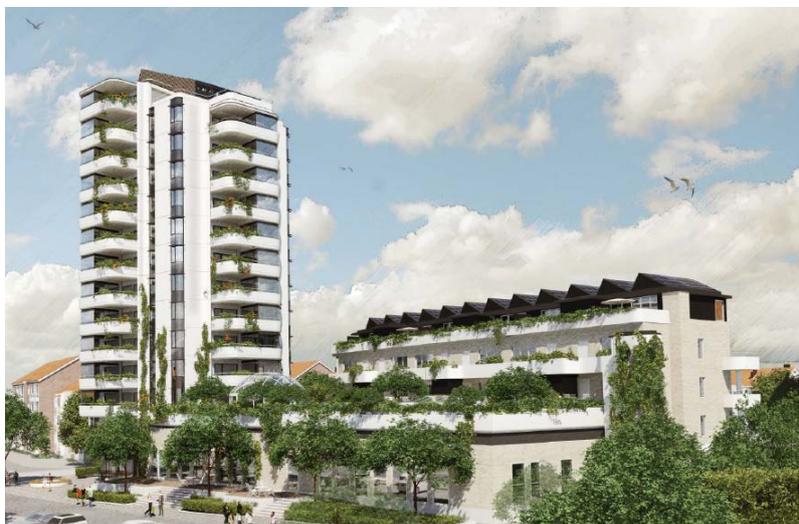
The Greenhouse construction project consists of three interconnected units: one fourteen-story building with about 34 apartments, twelve terraced houses and one eco-profile school building. On the roof of the fourteen-story building, there will be a rooftop garden with a large greenhouse for growing and social community. In particular, this roof garden will be linked to the Stage-2 project. As for Hornslandet: input, analysis, evaluation, documentation and follow-up of the entire green roof construction system will be delivered by the project.

Figure 4: Greenhouse, planned in Augustenborg, Malmö.

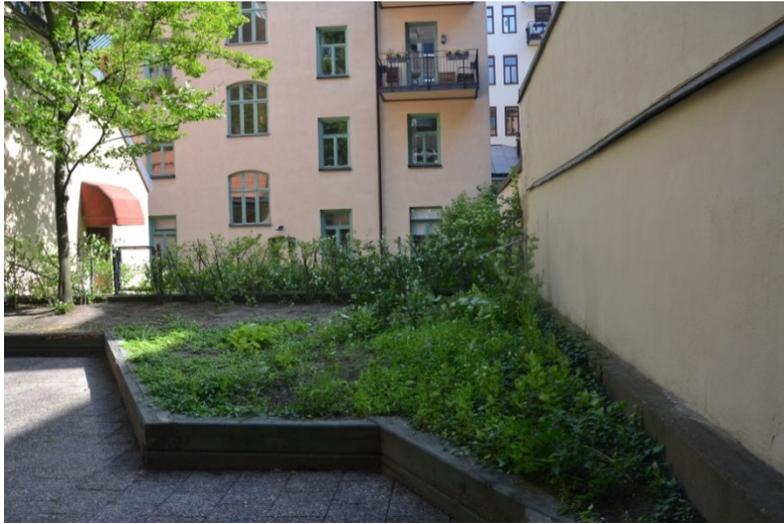
Figure 5: Green roof courtyard causing leakage in the garage below ground.

Furthermore, a green roof courtyard, covering an underground parking garage, is linked to the project. After some 50 years after construction, this

courtyard has to be renovated due to severe leakage into the garage for a long time. The concrete deck construction has been investigated and suitable measures have been proposed concerning concrete and waterproofing layer so far. Root penetration is likely the main cause for leakage. As for the two roof garden cases mentioned above: input, analysis, evaluation, documentation and follow-up will be delivered by the project.
